HULL CONDITION SURVEY REPORT

“SXXXXXX”, 57 feet, keel laid 1975, Tolladine Builders (Worcester, UK); cruiser stern narrowboat

Report number: UKMBS-22-011

Date: 19th March 2022

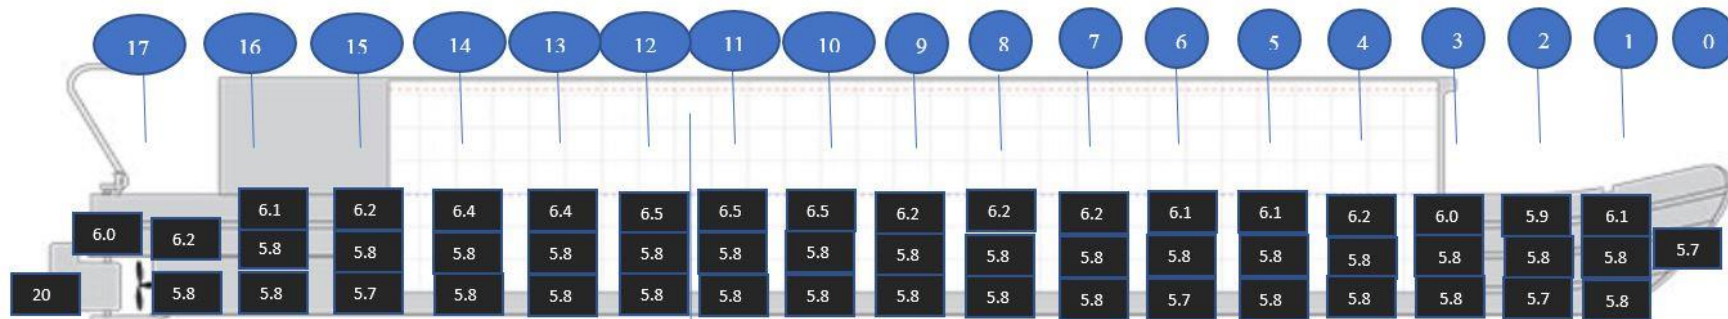
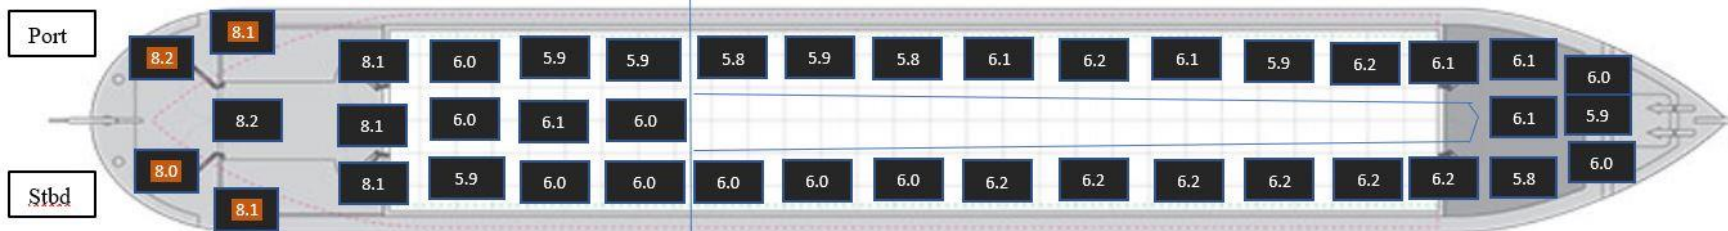
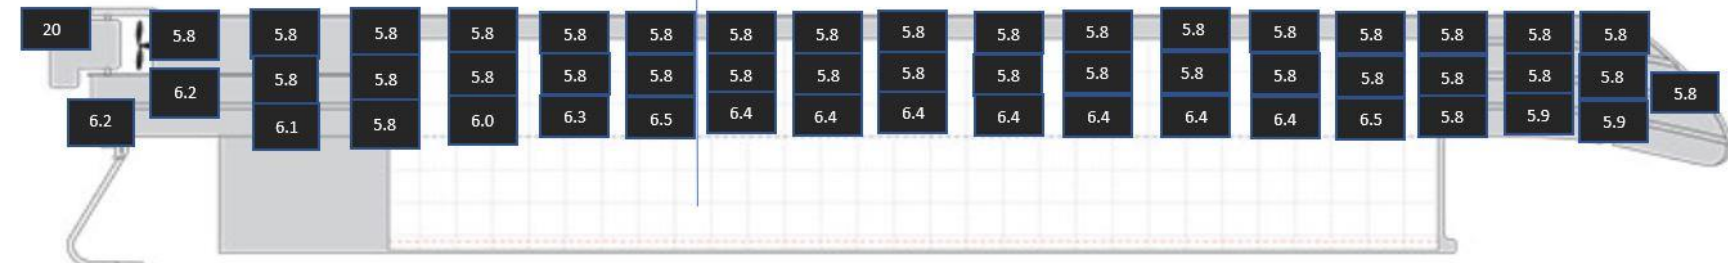
Readings were taken of underneath the keel plates and shown on the diagram Fig 1. Readings were taken at the tuck/swim at random points – seen on Plan section of Fig 1.

That is, not to say, that it was not possible for that to occur elsewhere on the craft. Should the hammer penetrated the plating that surrounding area would be mapped at much closer points to obtain readings to map the extent of the affected metal surface reduction. The findings on the day shown visually in the diagram Fig.1 below are in Millimetres.

Fig. 1 - Diagram showing ultrasound thickness readings on the flat-bottomed hull, tuck/swim and port and starboard sides of SXXXXXX. Plan and side views. All readings were mapped in millimetres.

The trailer supports were located at many areas that made some keel plate readings difficult. Access was difficult to take readings at the central keel in these positions due to design of trailer layout. Fig 1 has blue lines on it that show where it was difficult to obtain keel plate readings on the day.

Overall, no porosity was noted in the welds. The thinnest plate thicknesses can be seen in Fig 1.

Advisory Note: Monitor these locations in the coming years. It is an imperative to keep magnesium anodes in top condition and provide enough of them to protect the craft.

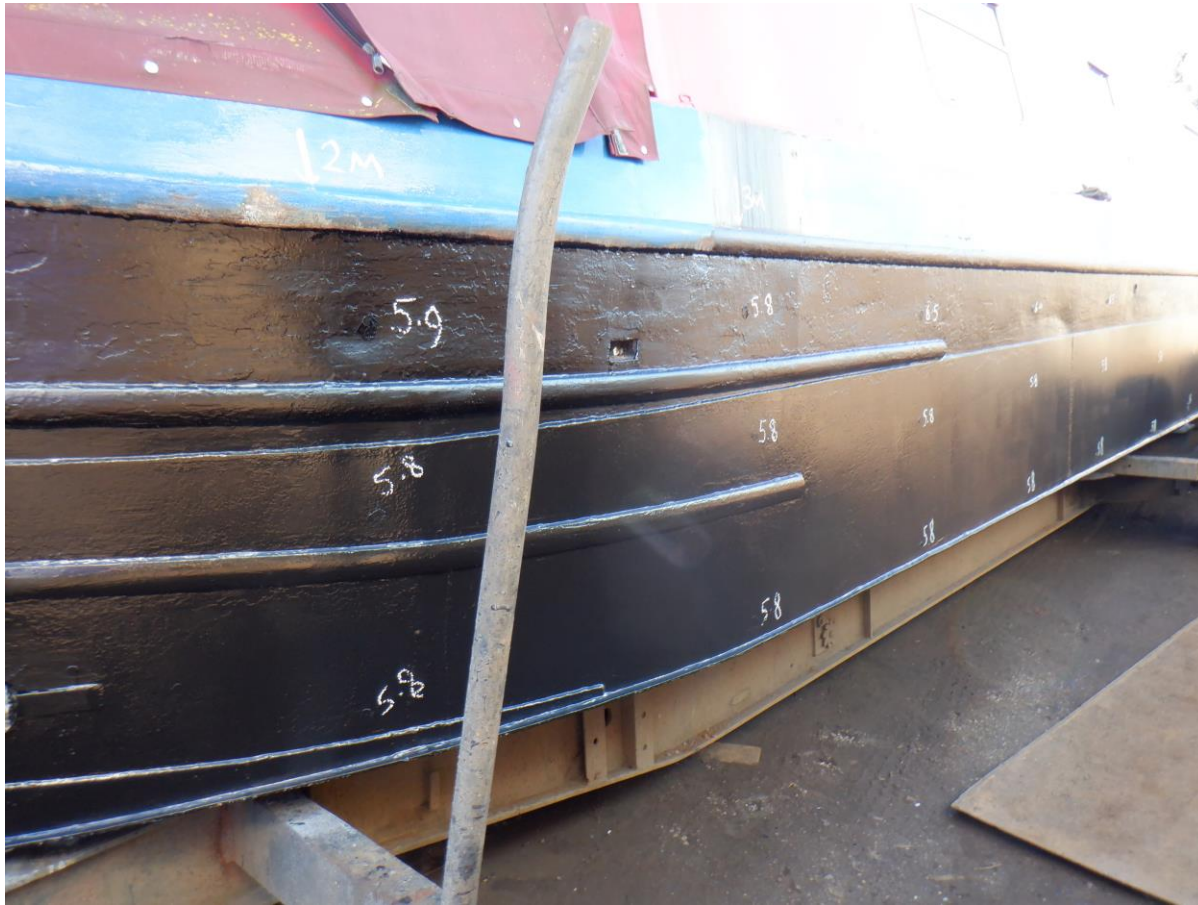
In 2018, mild steel side over-plating was welded to the original sides of the craft using 6mm mild steel both port and starboard. Height of footing was 60cm and situated above the sacrificial chine seam.

Fig 2 – Trailer supports and added mild steel side plating: 6mm

Supports located from bow towards aft at 1 metre; then 8.0 metres and 11 metres spacings. Fig 2

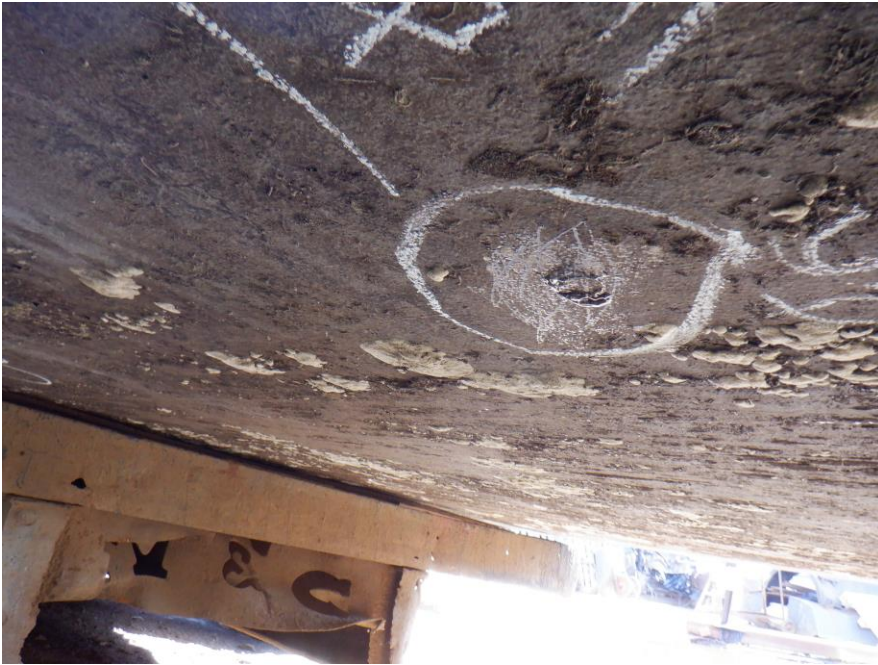
Fig 3 Forward bow section keel plate at 13m area.

Recent applications of 2 pack epoxy treatment had contributed to the good state of keel plate. Very little pitting was noted that would cause the Owner's concern due to craft's age and previous remedial work. Usually, when paint coatings are in poor condition, especially around high abrasion areas above the waterline; renewal of paint surfaces must occur. The cheapest way of doing this is to pressure wash the hull, wire brush any loose material and re-coat with more blacking.

However, given the good condition of the hull overplating for the age of the boat (1975 build), I would recommend (B) a long-term finish was applied by taking the hull back to bare metal using hydro, grit, shot, or slurry blasting and then coating it with a two-part epoxy coating. Now would be good time to do that. It would provide much better long-term protection of keel plating, swim, tuck, and side "under water" plating to maintain necessary plate thicknesses.
